PRODUCT DATA SHEET

ERS-312-6 ERS-312-12

REPAIR MESH

COATED FIBERGLASS REPAIR FABRIC

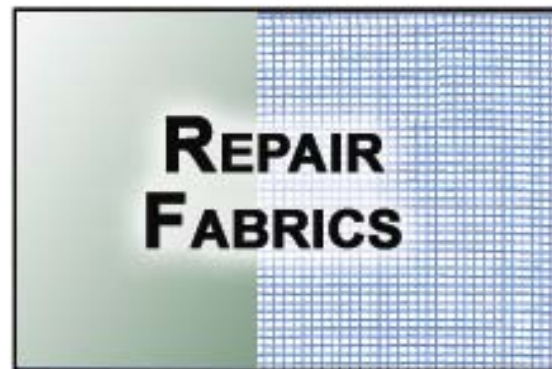
TOUGH ROOF REPAIR MEMBRANE

The success of any roof repair is dependent on the proper selection of a fabric reinforcement that will prevent the weak or damaged roof area from redeveloping leaks. With Ecology's flexible ERS-312 Mesh Reinforcement, exceptional tensile strength is provided over the repair area. The fabric is designed with an open weave pattern that permits full embedment into the waterproofing application of roof repair mastic preventing the formation of blisters or air pockets. The glass-fibered fabric has been treated with a blue polyvinylchloride coating to protect and secure the fibers, while providing added workability over irregular surfaces. ERS-312 is lightweight, rot resistant and meets ASTM D 1668 Type III.

ERS-312 can be installed with any of Ecology's cold process roofs cements or roof elastomers when repairing or reinforcing flashing terminations, open lap joints, mat splits or as a reinforcement during blister, ridge, or other mat repairs. The membrane should be fully embedded with a trowel into freshly applied roof mastic and completely covered with mastic to create a sandwich effect. When added strength is desired, more than one layer of ERS-312 can be used between applications of mastic. The rot resistant characteristics of ERS-312 allow it to be used to make repairs when wet roof conditions exist.
